Protection of River Water Tanks

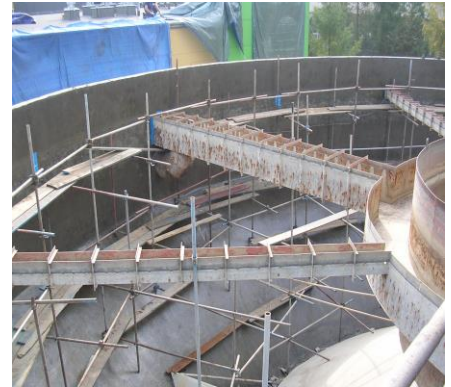
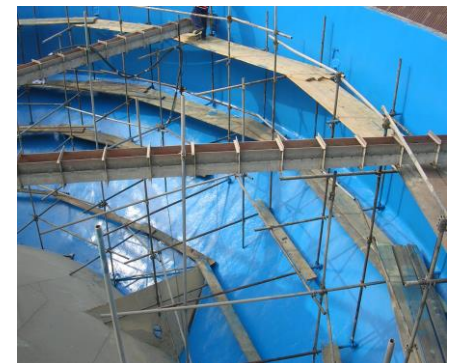
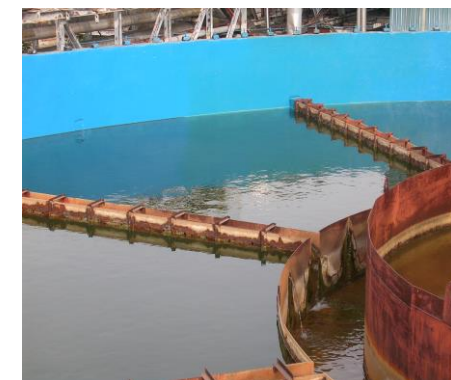
The concrete tanks located in Poland had been in operation for over 8 years and are used to hold river water. The existing coating had eroded over a period of time and the concrete surface was being affected by continuous immersion in water.

The concrete tank was drained and allowed to dry for 10 days.

The concrete surface was abrasive blast cleaned to remove any existing coating or contamination.

A single coat of DEP 505 Dampseal primer was brush applied to the concrete surface at approximately 250microns.

Once the material had reached initial set, a single coat of DEP501 Chemcoat CR was applied by airless spray at 300-350 microns.
